DEPARTMENT OF TRANSPORTATION

Contract #: 04-0120F4Cty: SF/ALA Rte: 80 PM: 13.2/13.9File #: 69.28**WELDING INSPECTION REPORT****Resident Engineer:**Siegenthaler, Peter**Address:** 333 Burma Road**City:** Oakland, CA 94607**Report No:** WIR-022083**Date Inspected:** 08-Jan-2011**Project Name:** SAS Superstructure**OSM Arrival Time:** 700**Prime Contractor:** American Bridge/Fluor Enterprises, a JV**OSM Departure Time:** 1900**Contractor:** Zhenhua Port Machinery Company, Ltd (ZPMC), Changxing Island **Location:** Shanghai, China**CWI Name:** An Qing Xiang**CWI Present:** Yes No**Inspected CWI report:** Yes No N/A**Rod Oven in Use:** Yes No N/A**Electrode to specification:** Yes No N/A**Weld Procedures Followed:** Yes No N/A**Qualified Welders:** Yes No N/A**Verified Joint Fit-up:** Yes No N/A**Approved Drawings:** Yes No N/A**Approved WPS:** Yes No N/A**Delayed / Cancelled:** Yes No N/A**Bridge No:** 34-0006**Component:** OBG**Summary of Items Observed:**

BAY 14, OBG 13BW (NWIT # 08096)

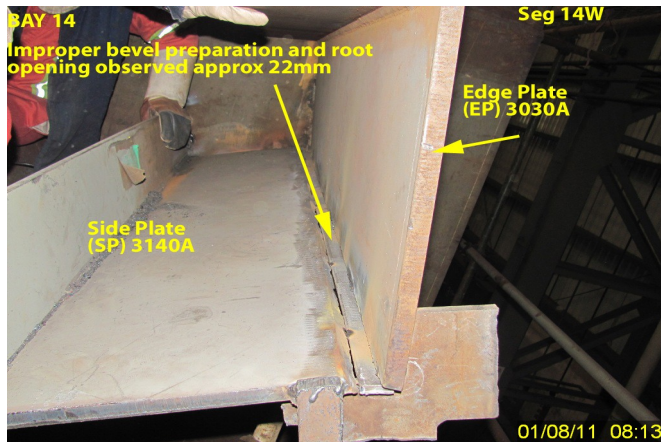
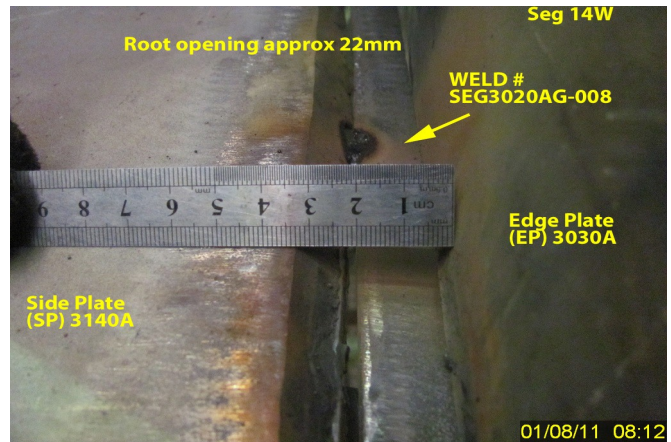
During random in process inspection this QA inspector observed there was improper fit up for the weld number SEG3020AG-008 joining Side Plate (SP) 3410A to Edge Plate (EP) 3030A. The groove face was observed as damaged and the root opening observed approx 22mm, the backing bar used was not properly installed. This issue has been discussed with ZPMC CWI Mr. An Qing Xiang and CT lead QA. Mr. An Qing Xiang informed this QA that this issue would be corrected in a manner compliant with contract documents. Attached photograph provide additional details.
